House Inspection at

30 Honikiwi Rd Otorohanga

Sample Report

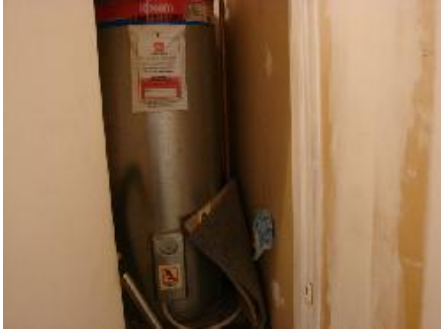
Hot water cylinder not restrained

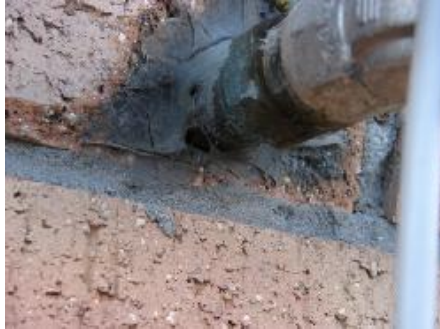
Poor sealing around pipework

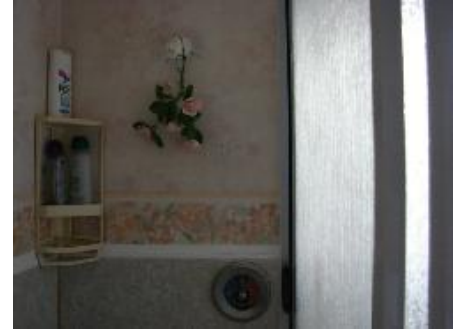
Shower over the bath is of minor concern for leaks

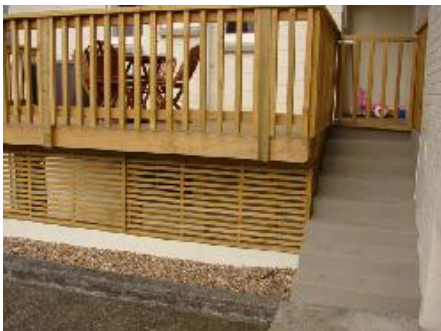
Deck has been added without a permit

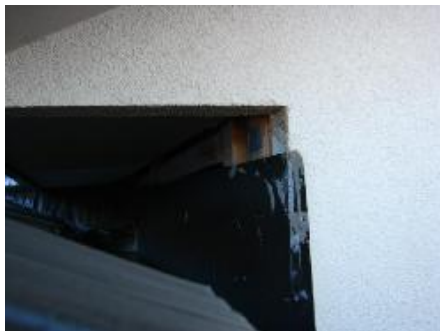
Flashing missing

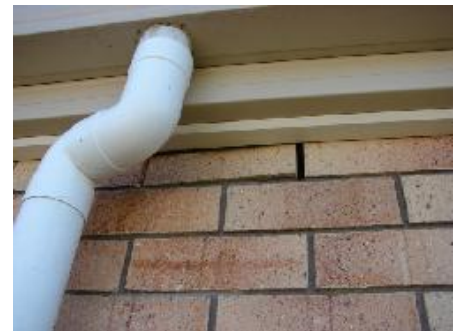
Loose brickwork

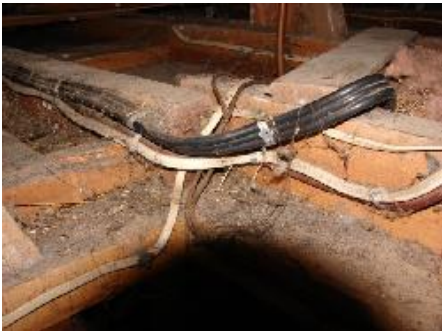
Unsure if all wiring has been replaced

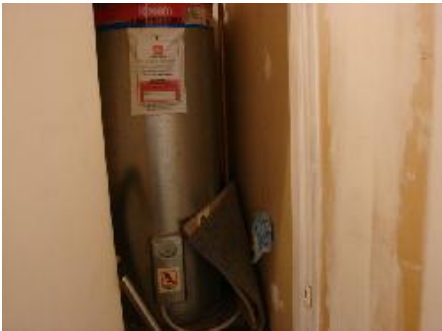
Hot water is not restrained

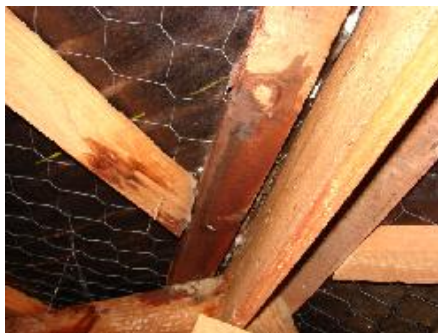
Roof Leak

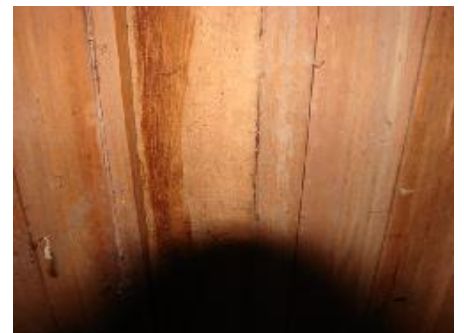
Only board located with borer

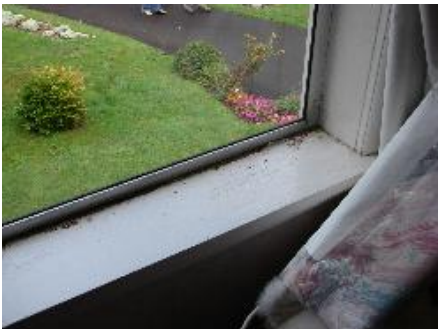
Front bedroom window sill

There are some minor faults with the condensation on the windows

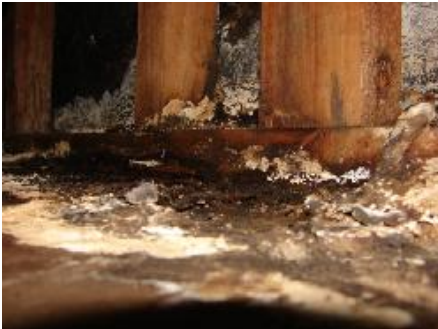
Leaks found from the shower over the bath.

Timber from under the bath

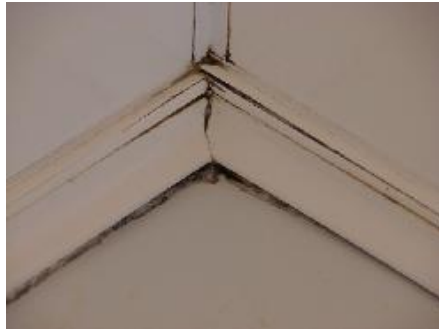
Plastic moulds around the bath that have broken and let the water through

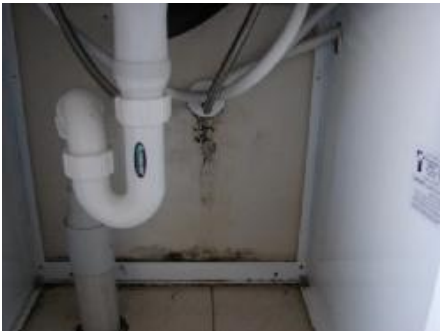
Leak under laundry tub

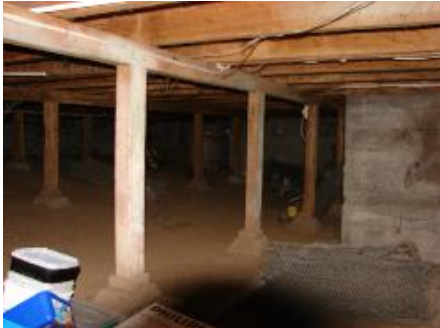
jack studs to bearers-no connectors

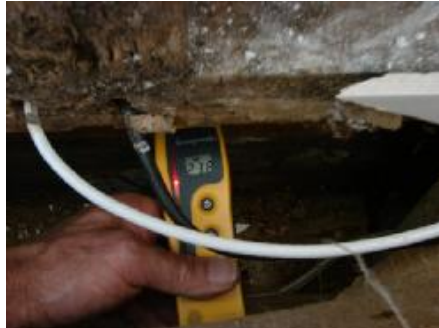
wet boards from hole drill in exterior wall

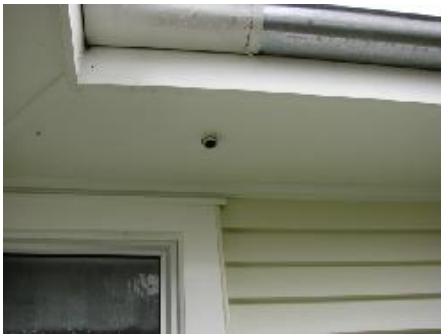
Replaced section of spouting

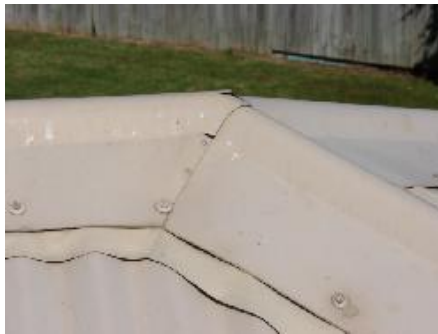
Ridge joints need sealant

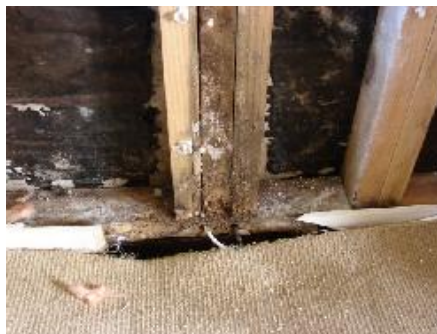
Leaking exterior wall

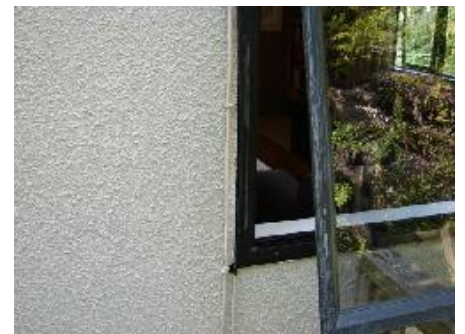
This is where the leak started
